# Manhole Inspection Summary

Manhole # S39U\_\_018MH

Insp Date: **3/13/08 2:43 PM**

**Location** Address: **1500 jackson st**

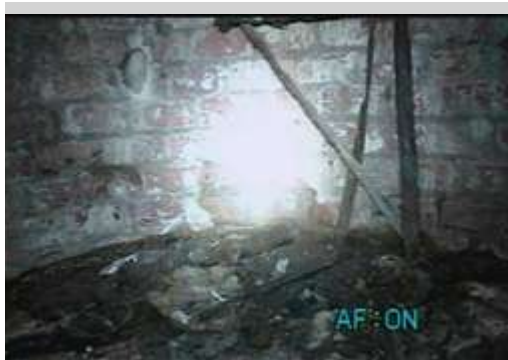
Defect 2

Condition: ☐ Sound ☐ Cracked ☐ Root Intrusion ☐ Deteriorated ☐ Leaks ☒ **Debris**

bench debris

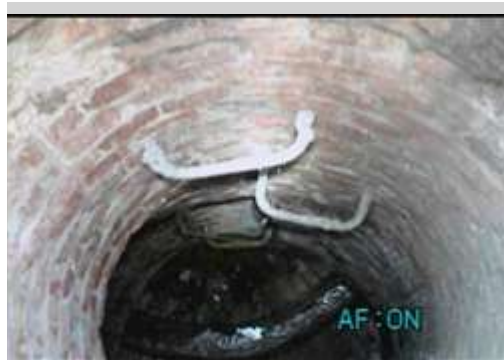
Defect 1

**Steps** Count: **5** Missing: **2** ☒ **Corroded**

corroded/missing steps

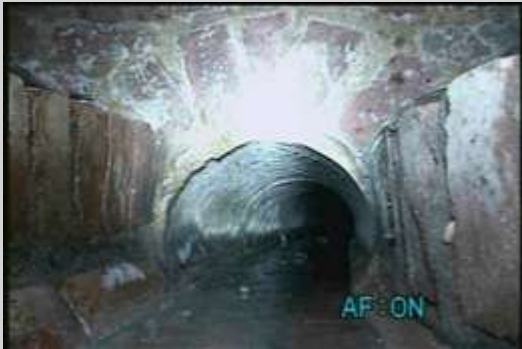
12 O'Clock Outflow

8 in. Circular Gravity Sewer  
Pipe Out @ 12 O'Clock

Invert Depth: **9.50** (ft.) Flow Characteristics: **Fast**

Deposits: ☒ None ☐ Mud ☐ Sludge ☐ Debris ☐ Grease

Infiltration: **None** Pipe Seal Cond: **Unknown**

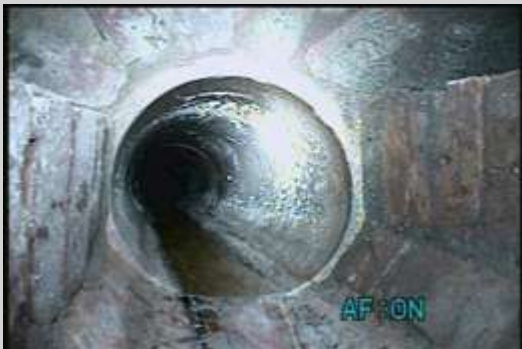
4 O'Clock Inflow

8 in. Circular Gravity Sewer  
Pipe In @ 4 O'Clock

Invert Depth: **9.40** (ft.) Flow Characteristics: **Fast**

Deposits: ☒ None ☐ Mud ☐ Sludge ☐ Debris ☐ Grease

Infiltration: **None** Pipe Seal Cond: **Unknown**
